08-01
Jan • 2008

AFCESA

Special Range-Top Fire Extinguishing Systems

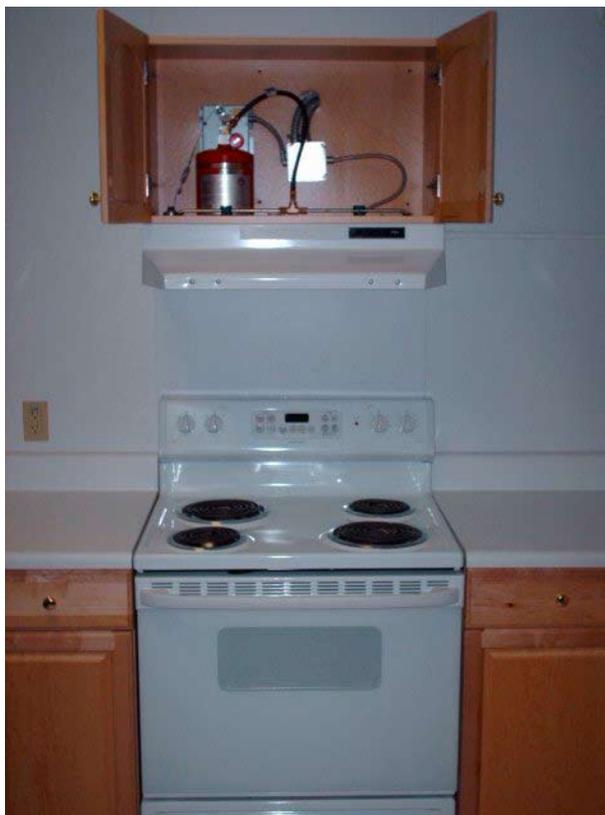
Above: Typical system installation. Right top: Fusible link. Right center: Safety pin in place. Right bottom: Safety pin removed.

Base Civil Engineers need to verify that the safety pin is **NOT** left installed on range-top fire extinguishing systems – including after annual maintenance.

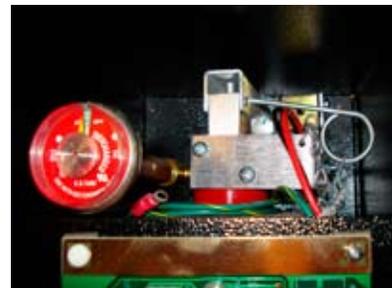
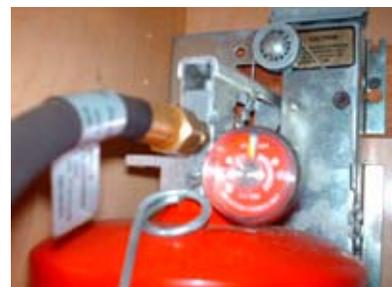
- The residential-type range-top fire extinguishing system is similar in appearance to a portable fire extinguisher.
- Checks of portable fire extinguishers include verification that the safety pin is installed.
- However, checks of range-top fire extinguishing systems must include verification that the safety pin is **NOT** installed.

At one base, 4 out of 5 systems inspected were found to be inoperable because the system safety pin had not been removed following initial installation or after annual maintenance. The manufacturers of these systems recommend yearly replacement of the fusible link – the safety pin needs to be in place when accomplishing this maintenance. **Following the maintenance, the safety pin must be removed** or the system will not operate in the event of a fire.
